RAC EQUIPMENT TRIALS WING
RAC CENTRE

WEAPONS BRANCH REPORT

CHARGES AND ADAPTORS, BLANK, FOR 105mm TK GUN L7

Project WB 441

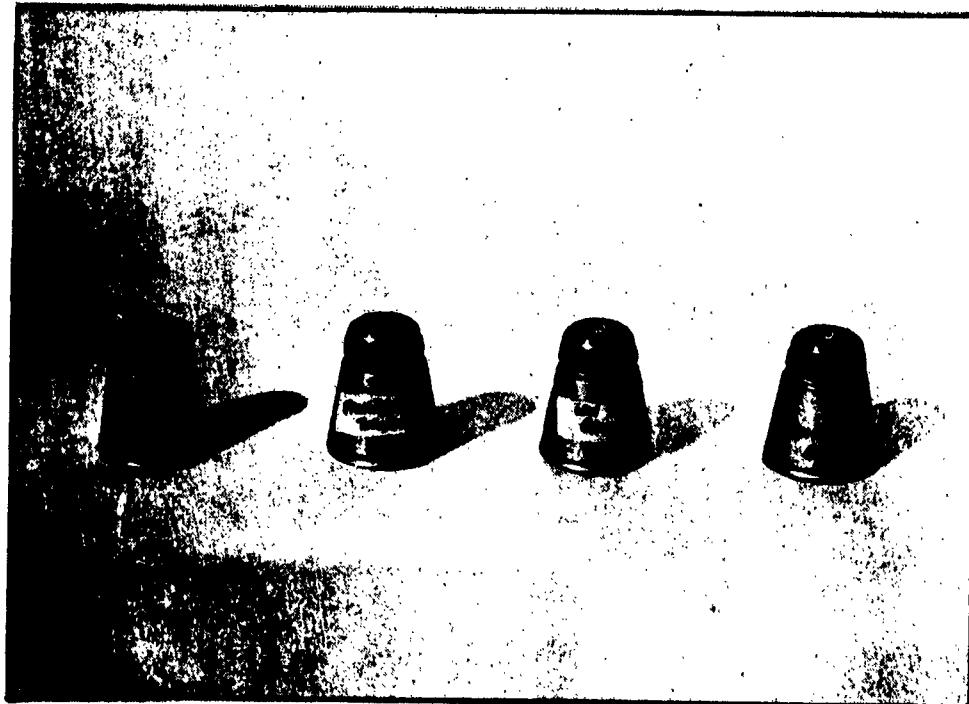
Photograph 2 - Charges, Blank, for 105mm Tk Gun L7

- b. Charges, Blank, which have the appearance of small truncated cones. (See photograph 2). A detonator is held in a brass plug at the smaller end of the cone. The charge fits into the adaptor (see photograph 3) by being lightly pushed against the spring, the lip at the base of the cone pushes the retaining plungers outwards against the action of their springs when the charge is inserted. When the charge is fully home the retaining catch springs reassert themselves and the charge is held in position. (See photograph 4). After firing the spent charge cone can be released by pressing the lower portion of the retaining plungers to allow the adaptor spring to push out the cone which can be removed by hand. The charge detonator cap makes contact with the electrical connector at the bottom of the adaptor cavity.

Some charges received were manufacturing rejects (see photograph 2) but all subsequently functioned satisfactorily. Defects were high or low gauge measurement and faulty cone lip turnover.
